Superstorm Sandy

Preparations, impact, recovery, and fortification

Society of American Military Engineers
September 17, 2013

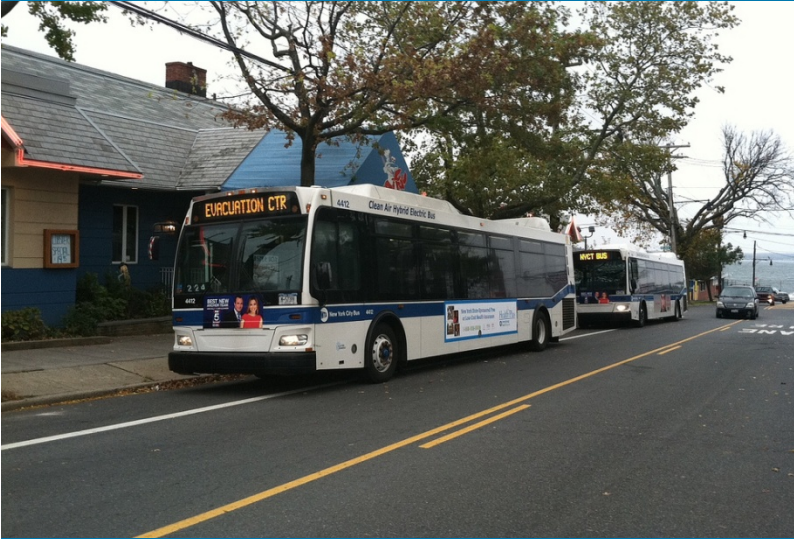
Buses staged for evacuation (City Island)

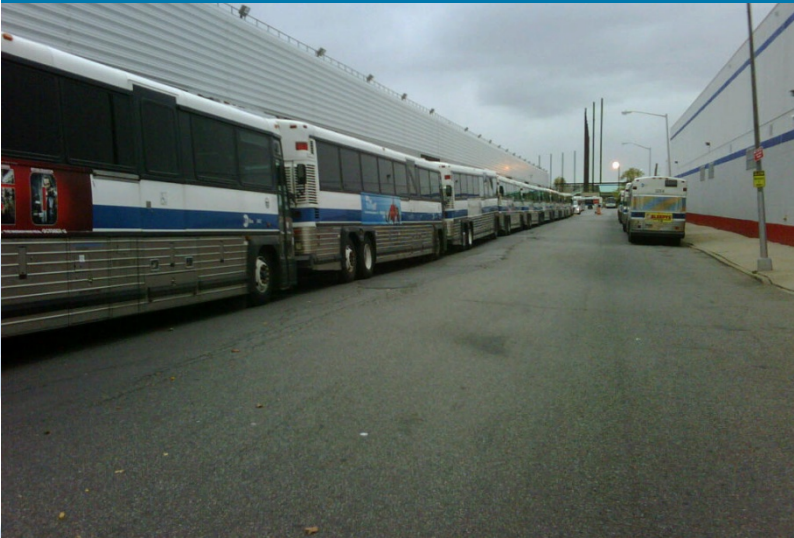
Buses relocated to higher ground (Gun Hill depot)

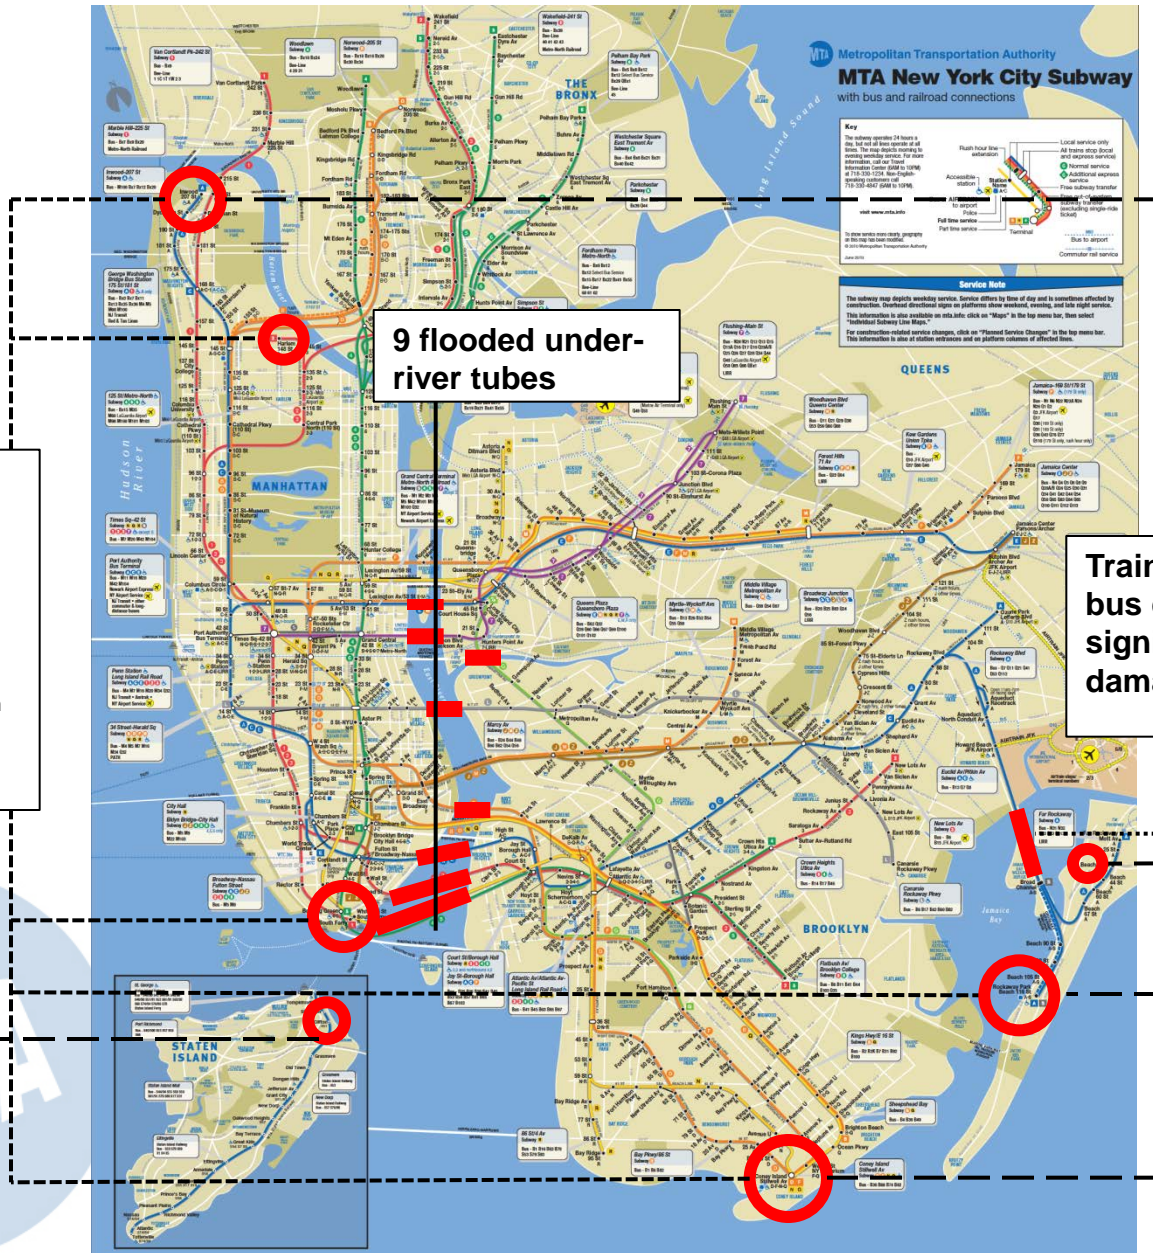
Sandy caused major flood damage across the system

9 flooded under-river tubes

8 stations with major flood damage – South Ferry, Whitehall, 148th St, 207th St, Dyckman, Beach 116th Station, 86th St Sea Beach, Stillwell

Train yards and bus depot with significant flood damage

Rockaways track washout

Staten Island Railway maintenance shop major flood damage

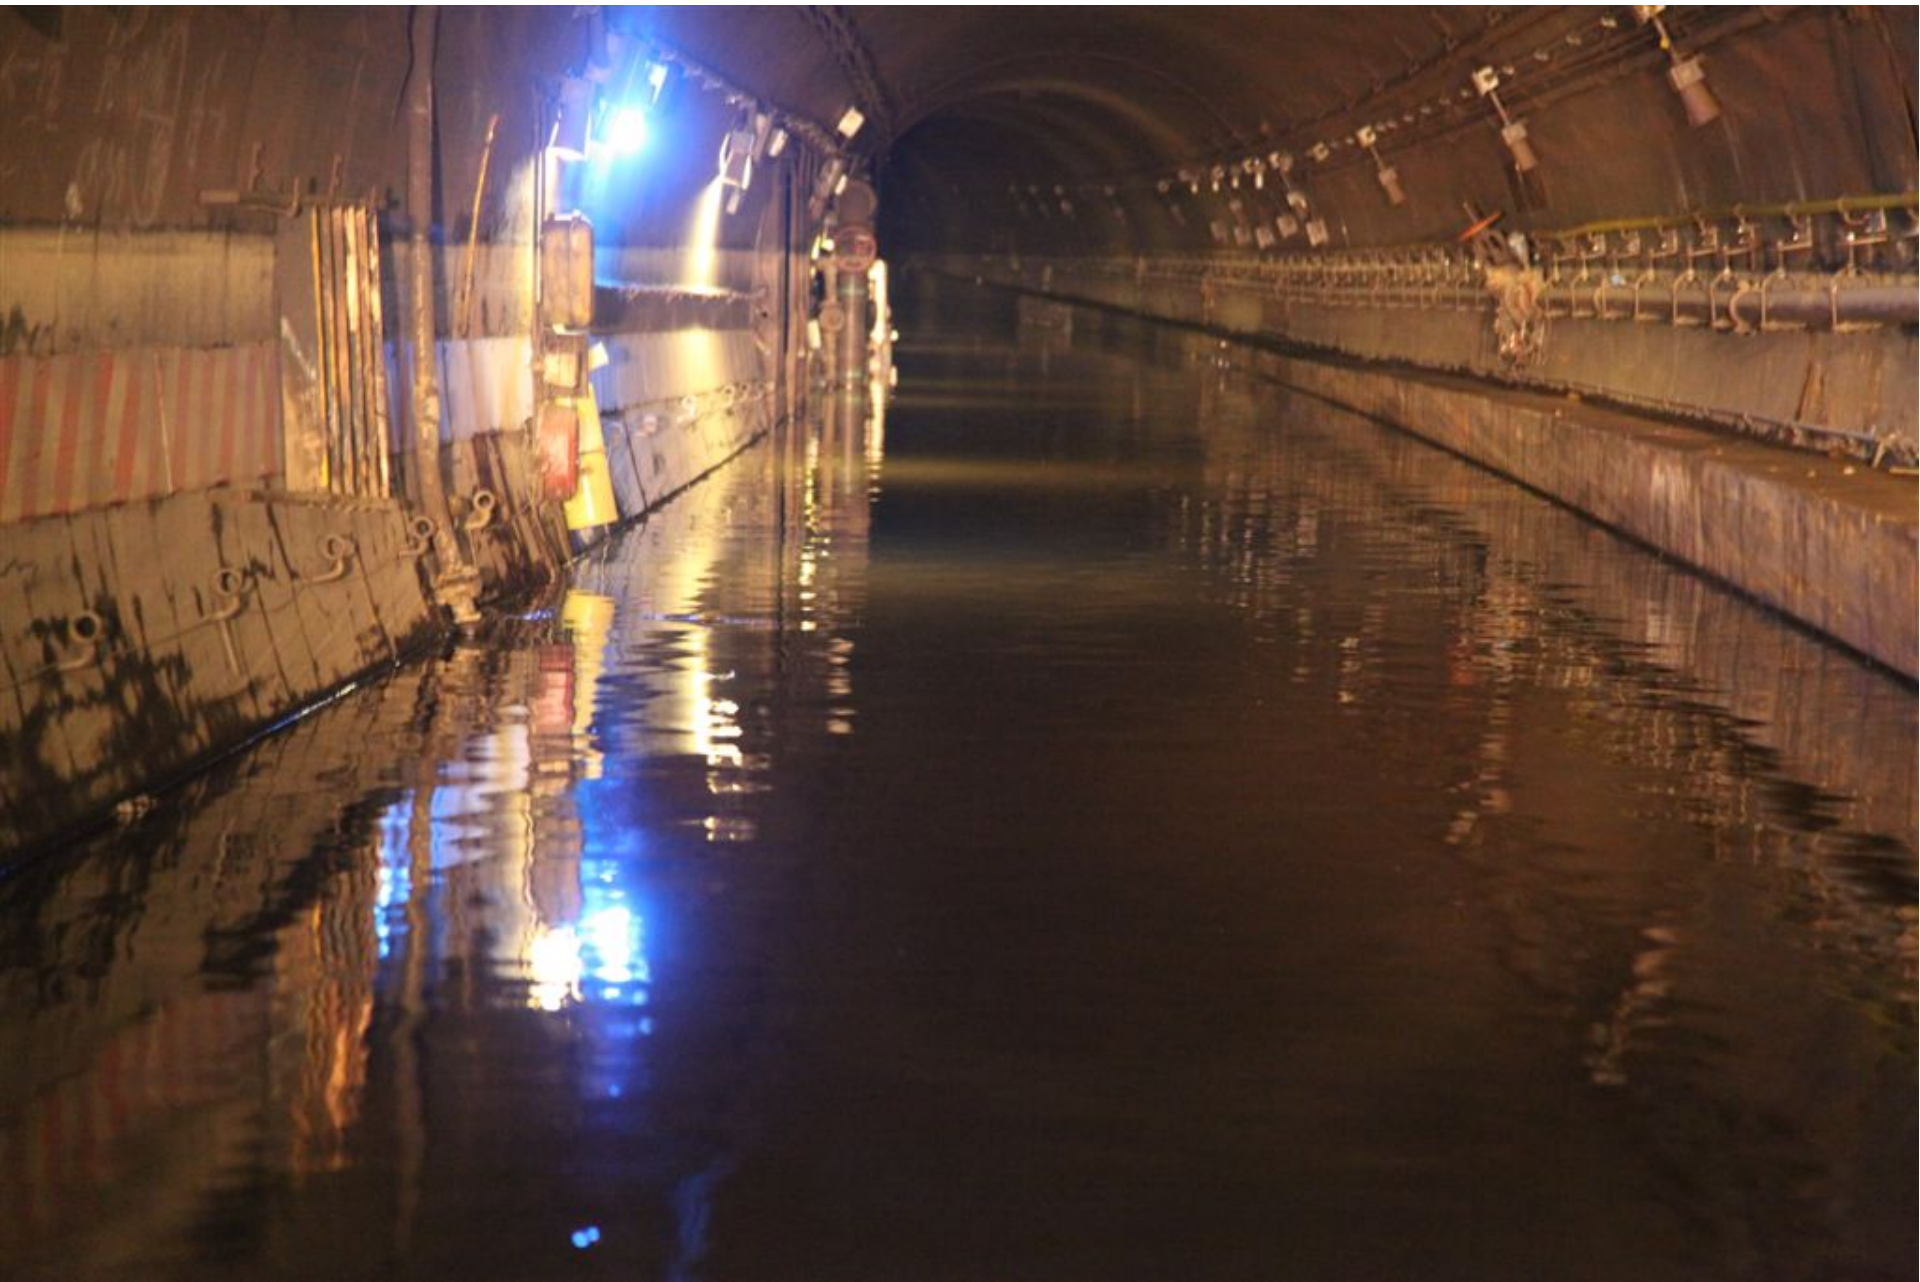
Flooded under-river tubes - Cranberry

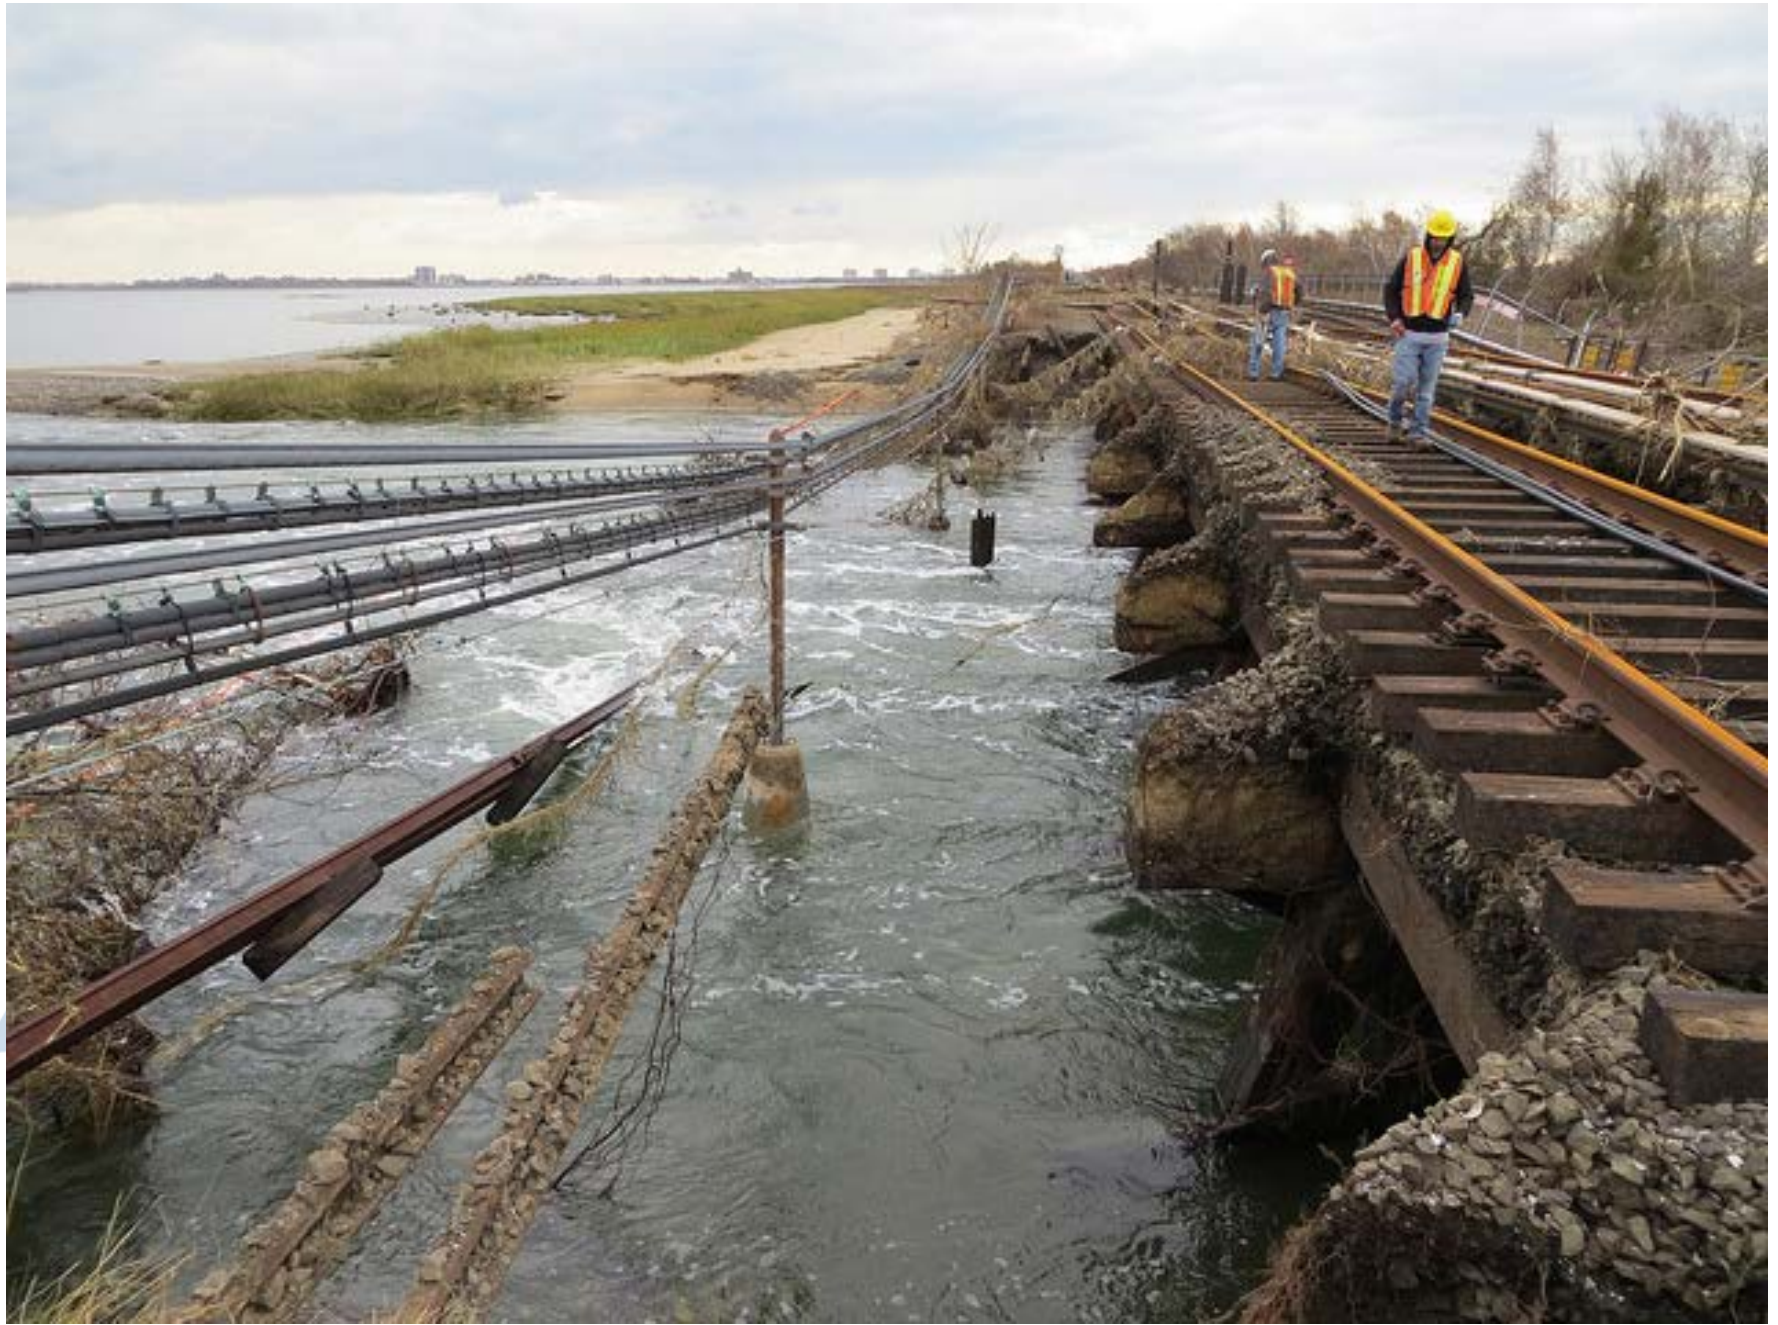
Rockaways washout

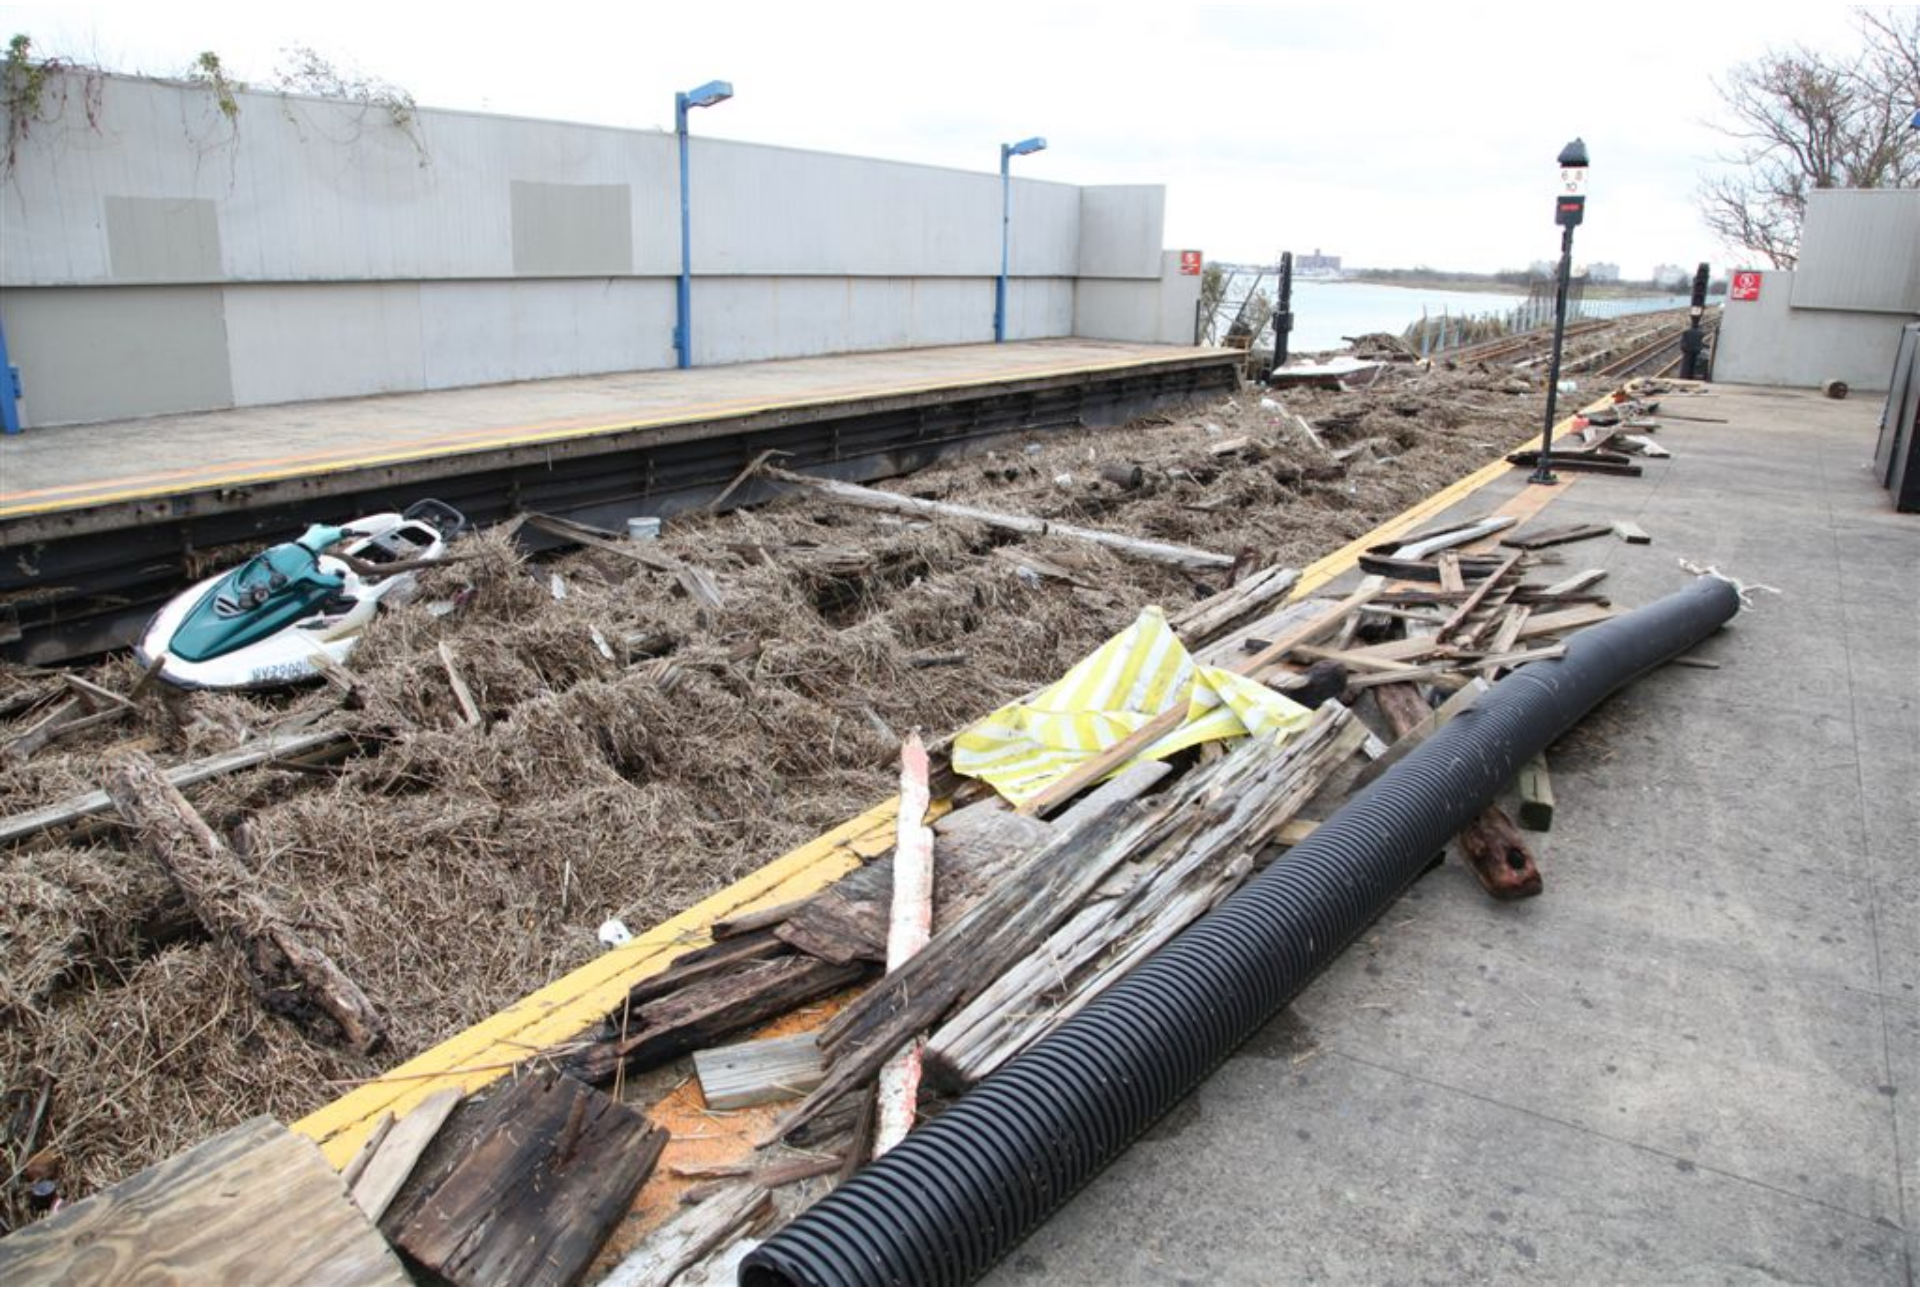
Rockaways washout

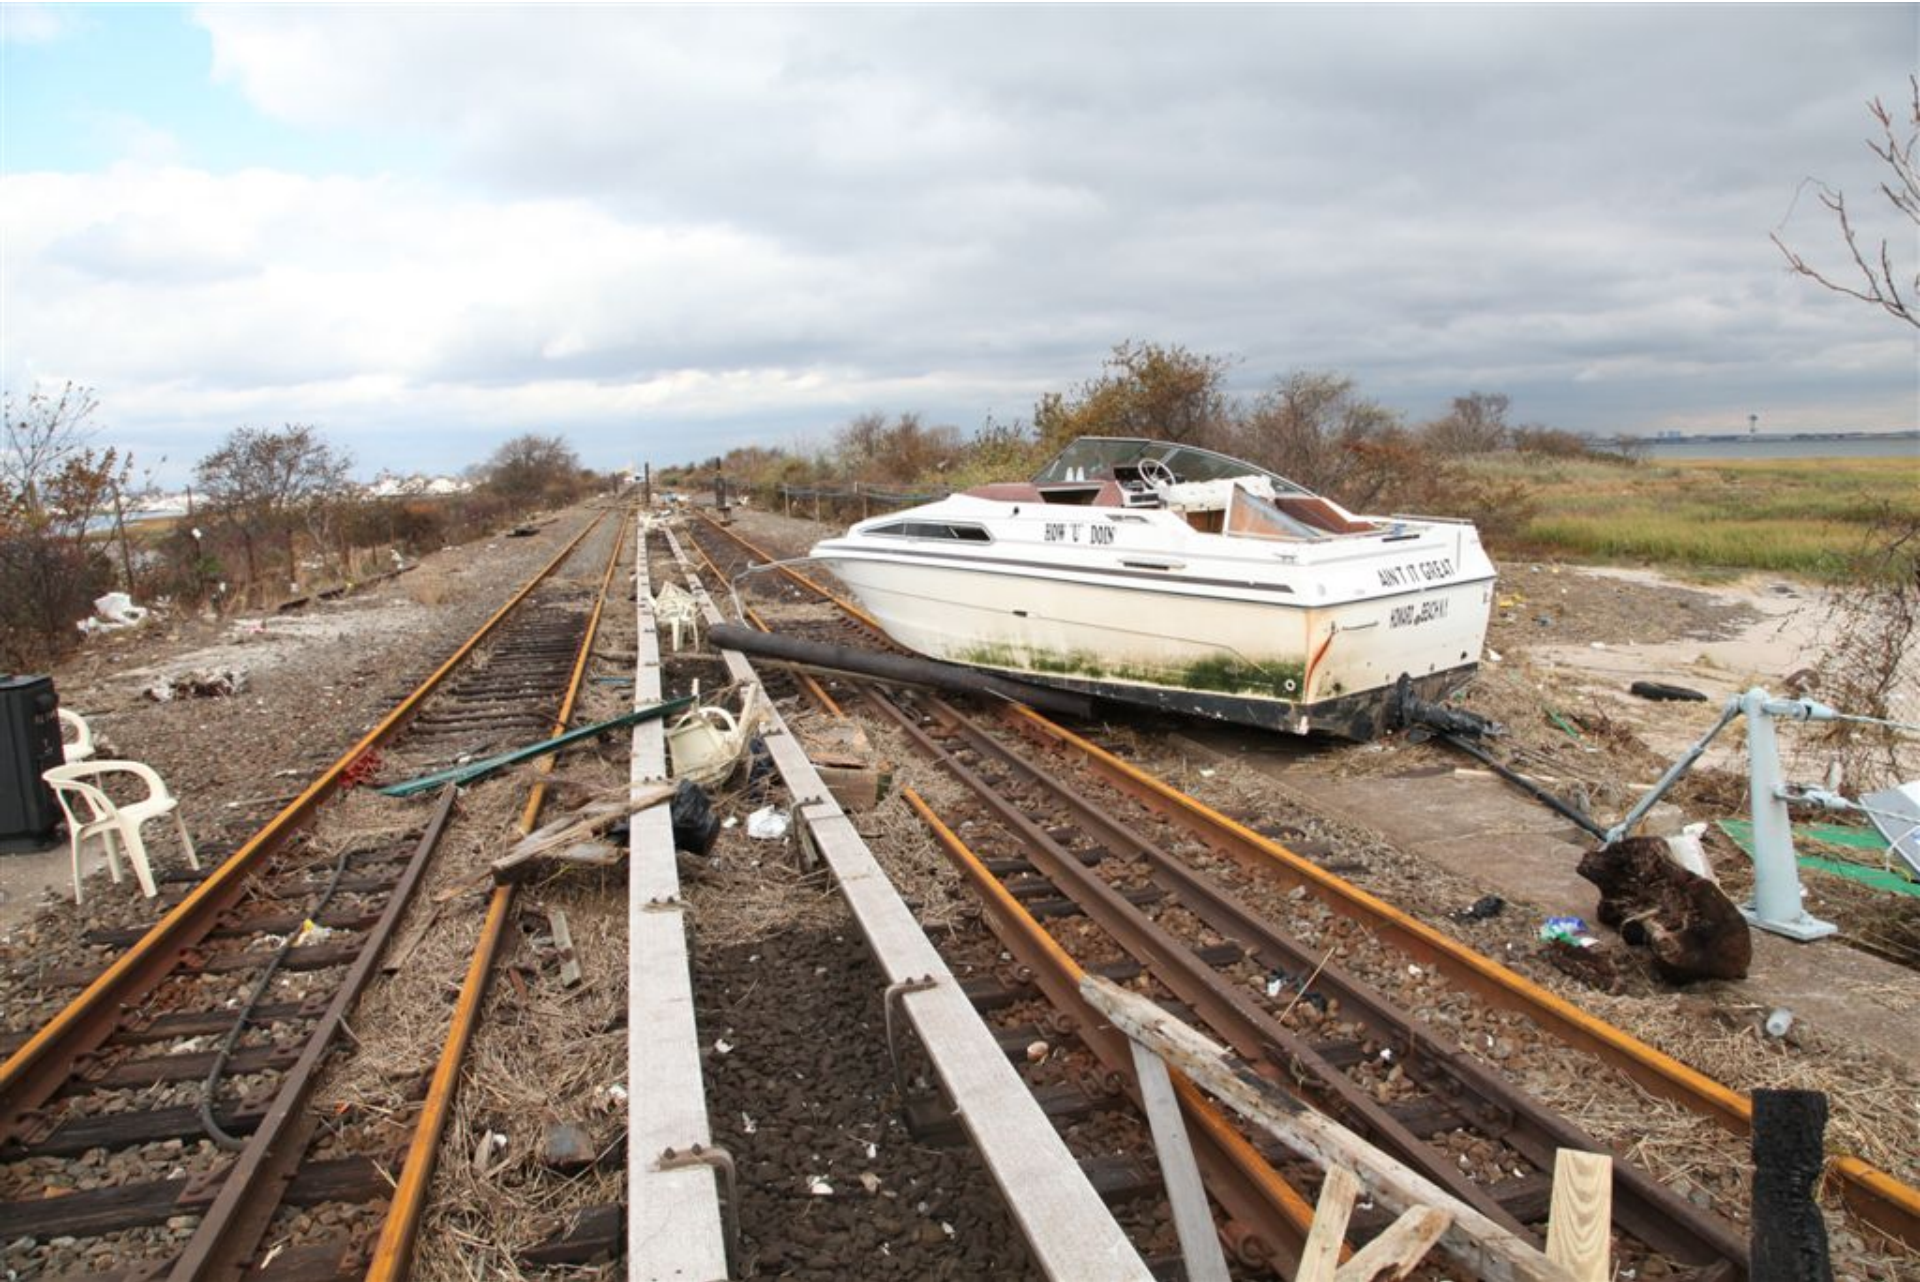
Rockaways washout

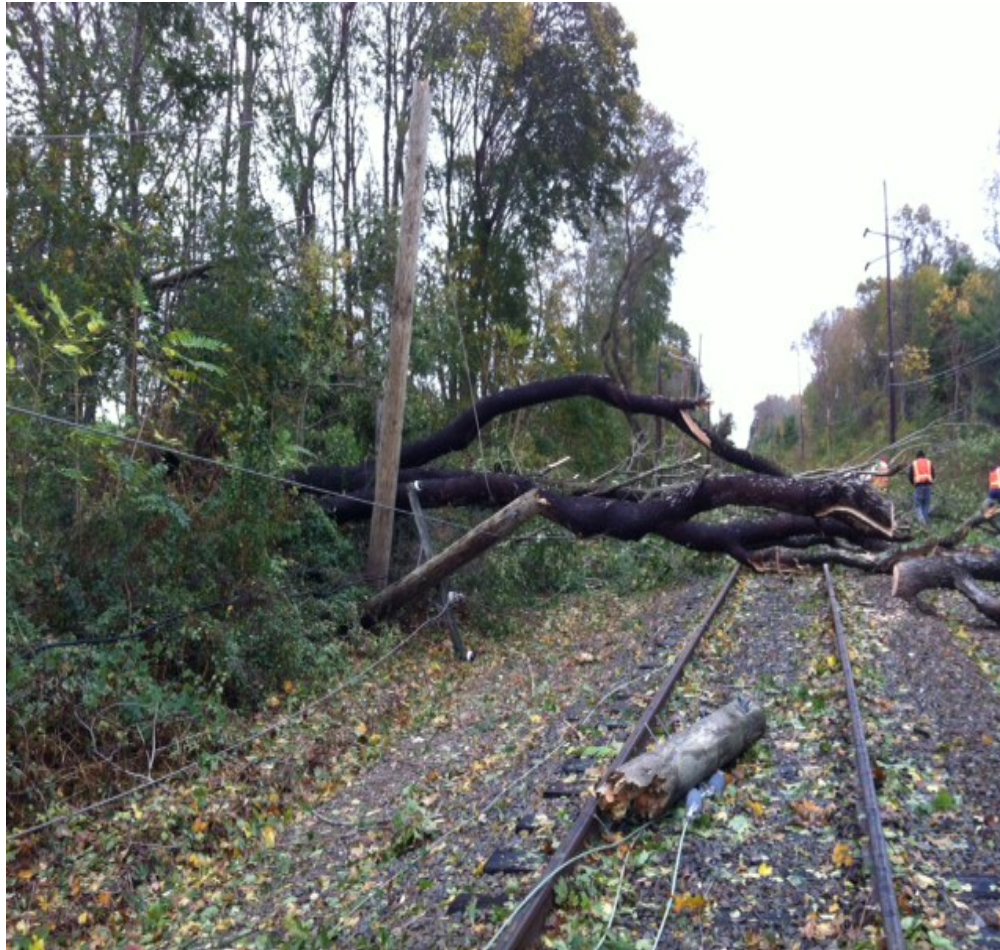
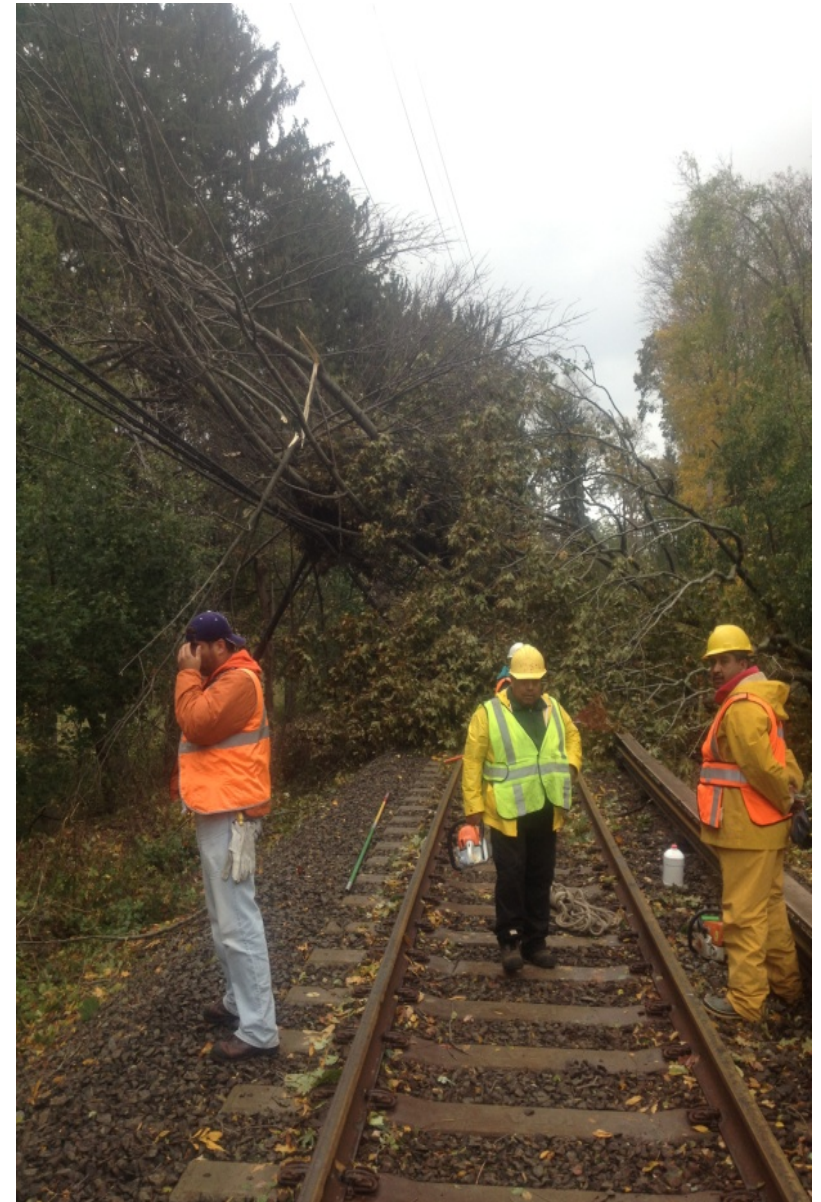
Trees and utility poles/wires down along the Long Island Rail Road

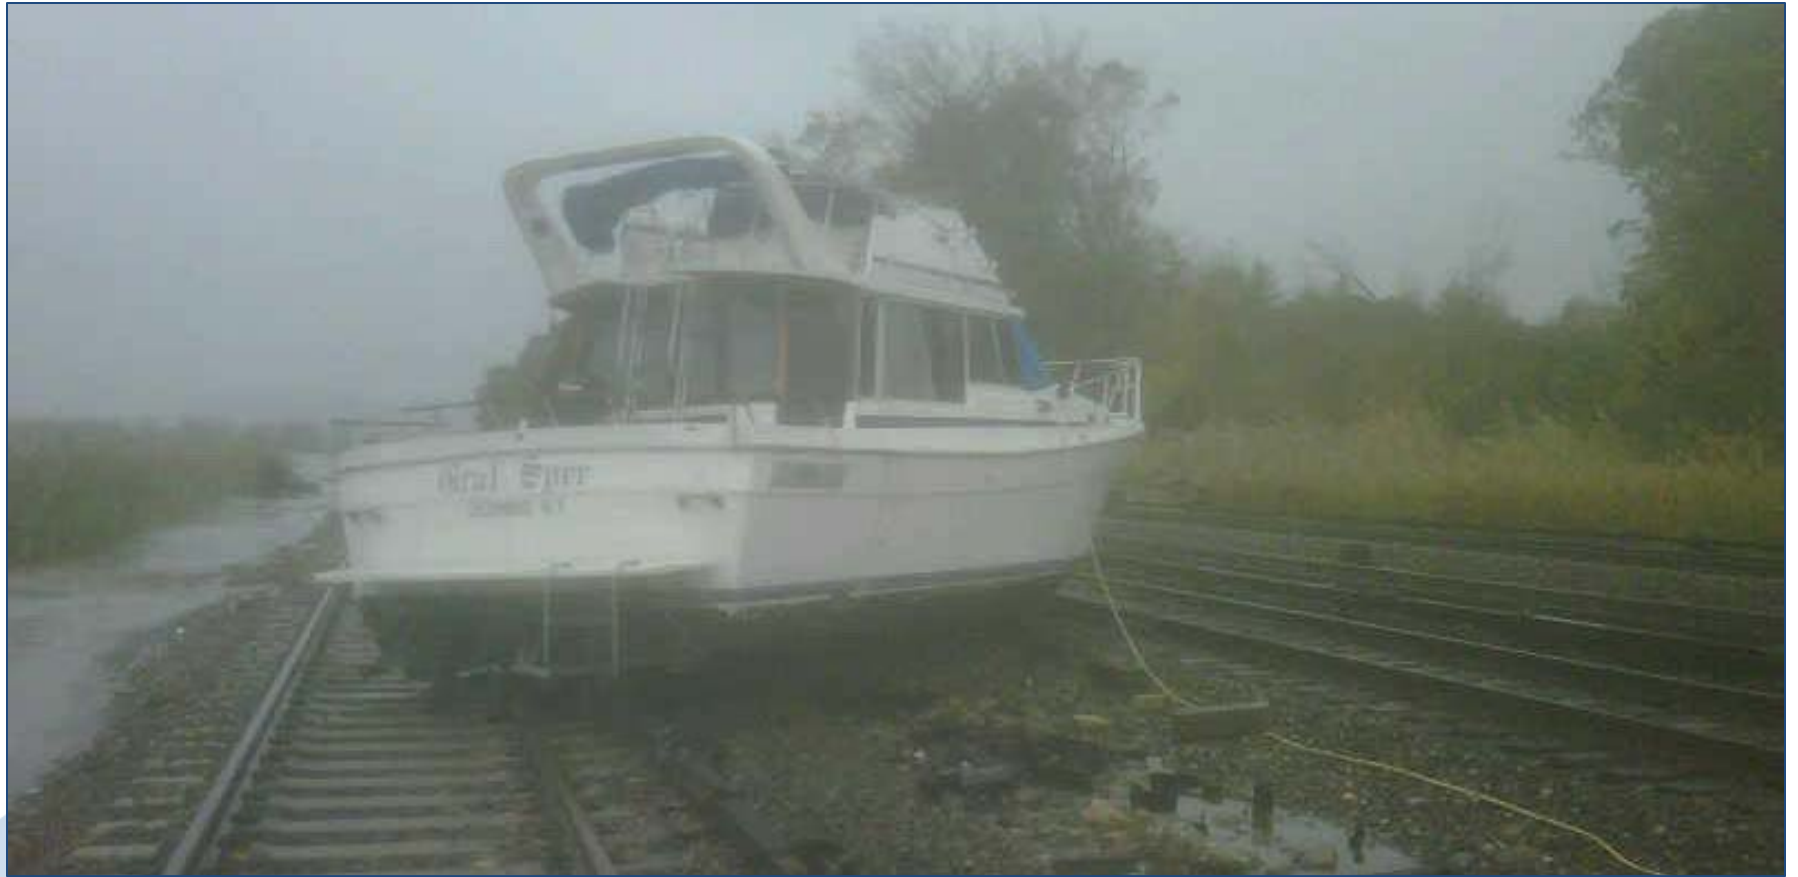
Stranded Boat along Metro-North's tracks at Ossining

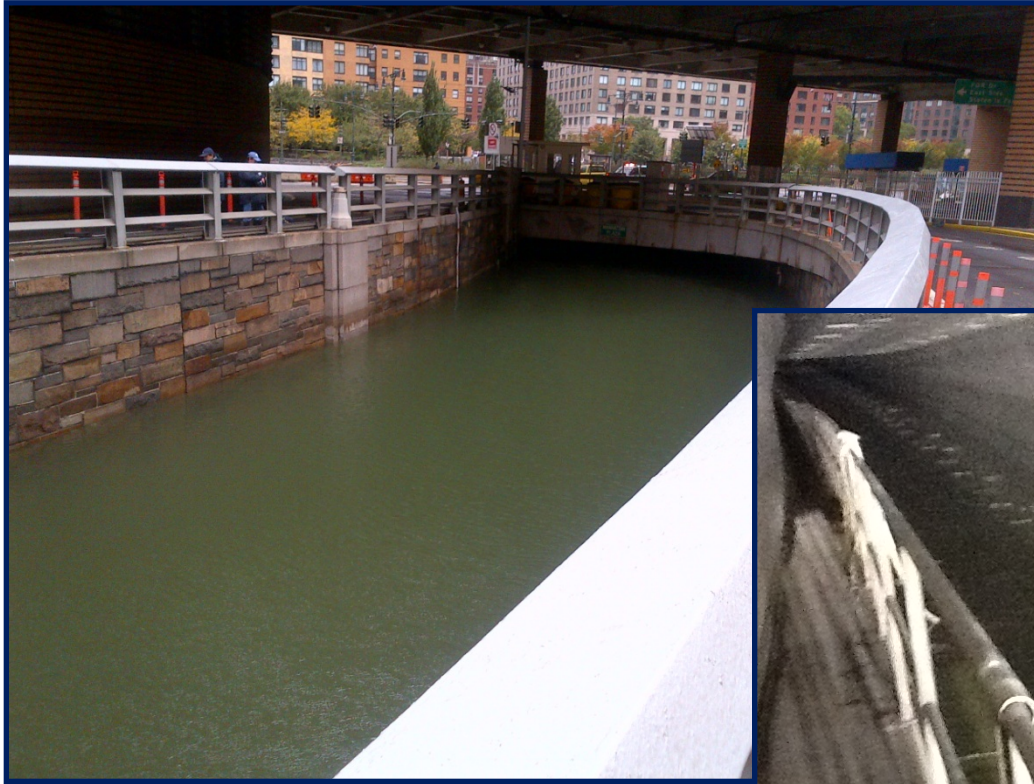
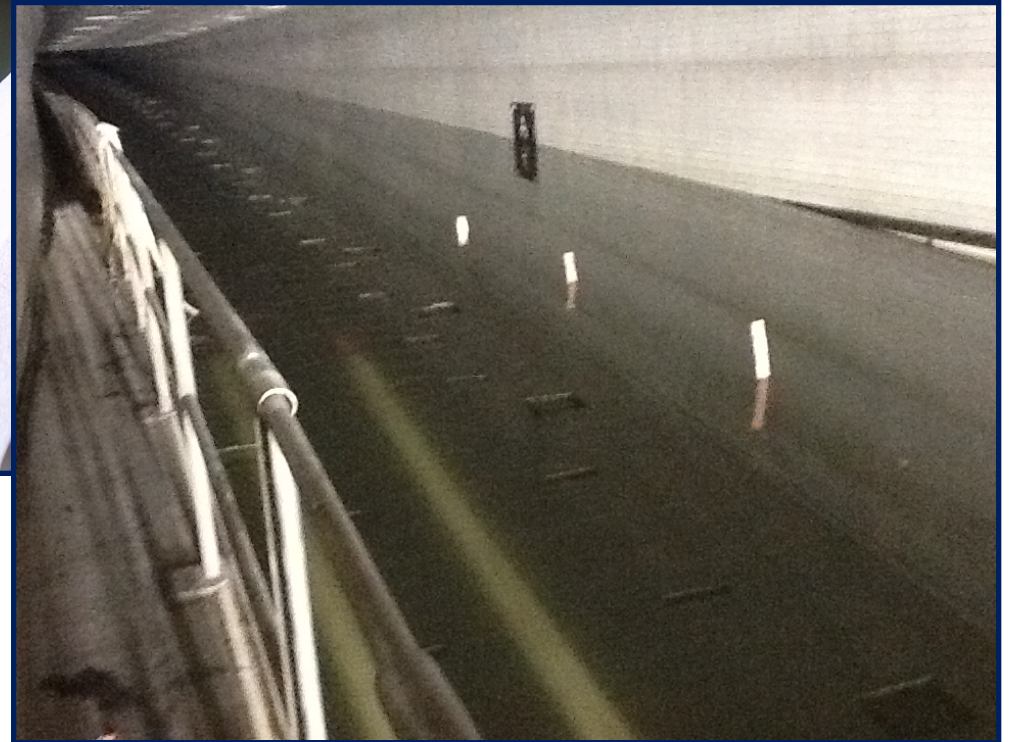
Hugh L. Carey (Brooklyn Battery) Tunnel west side underpass and tube

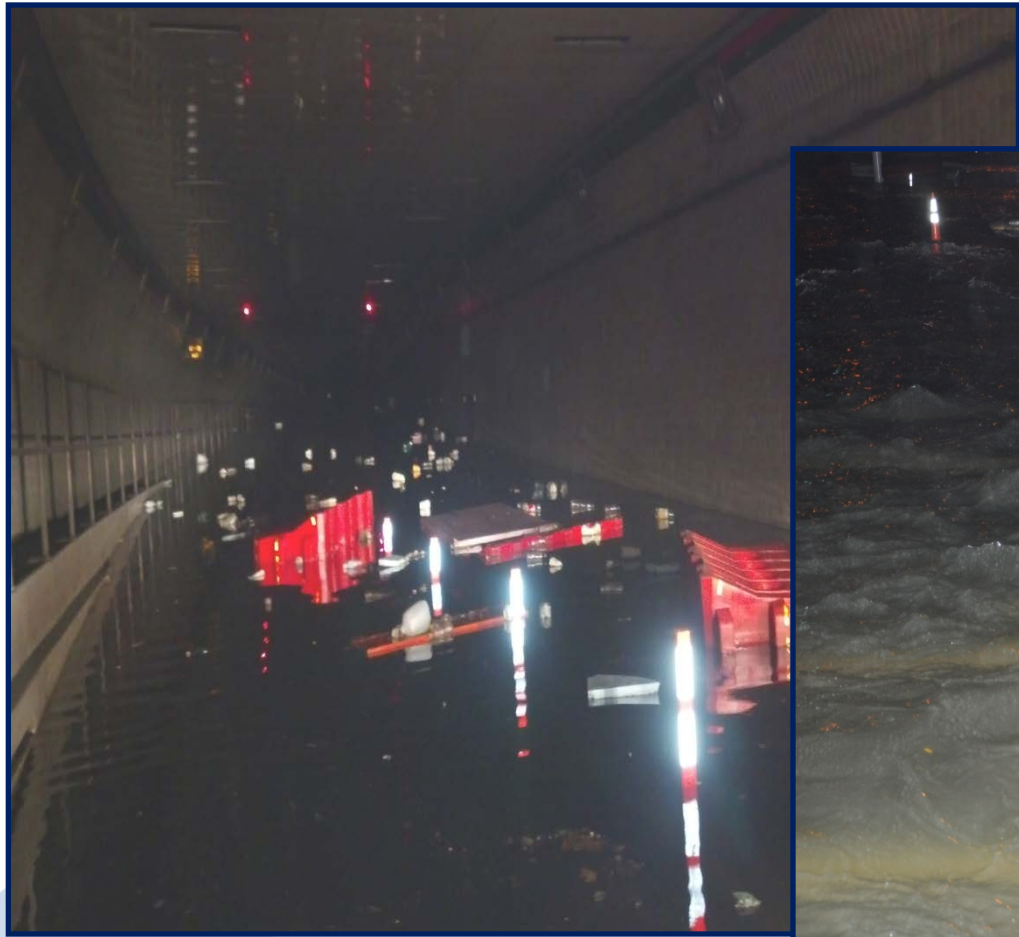
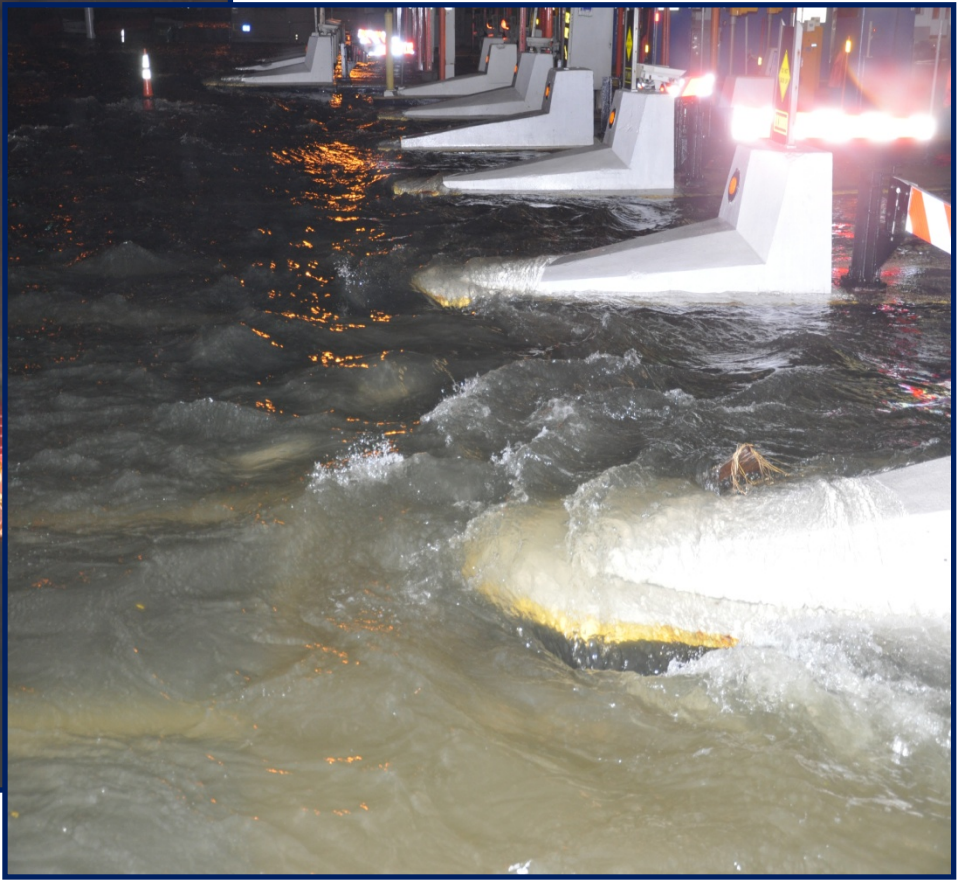
Flooded Queens-Midtown Tunnel tube and toll plaza

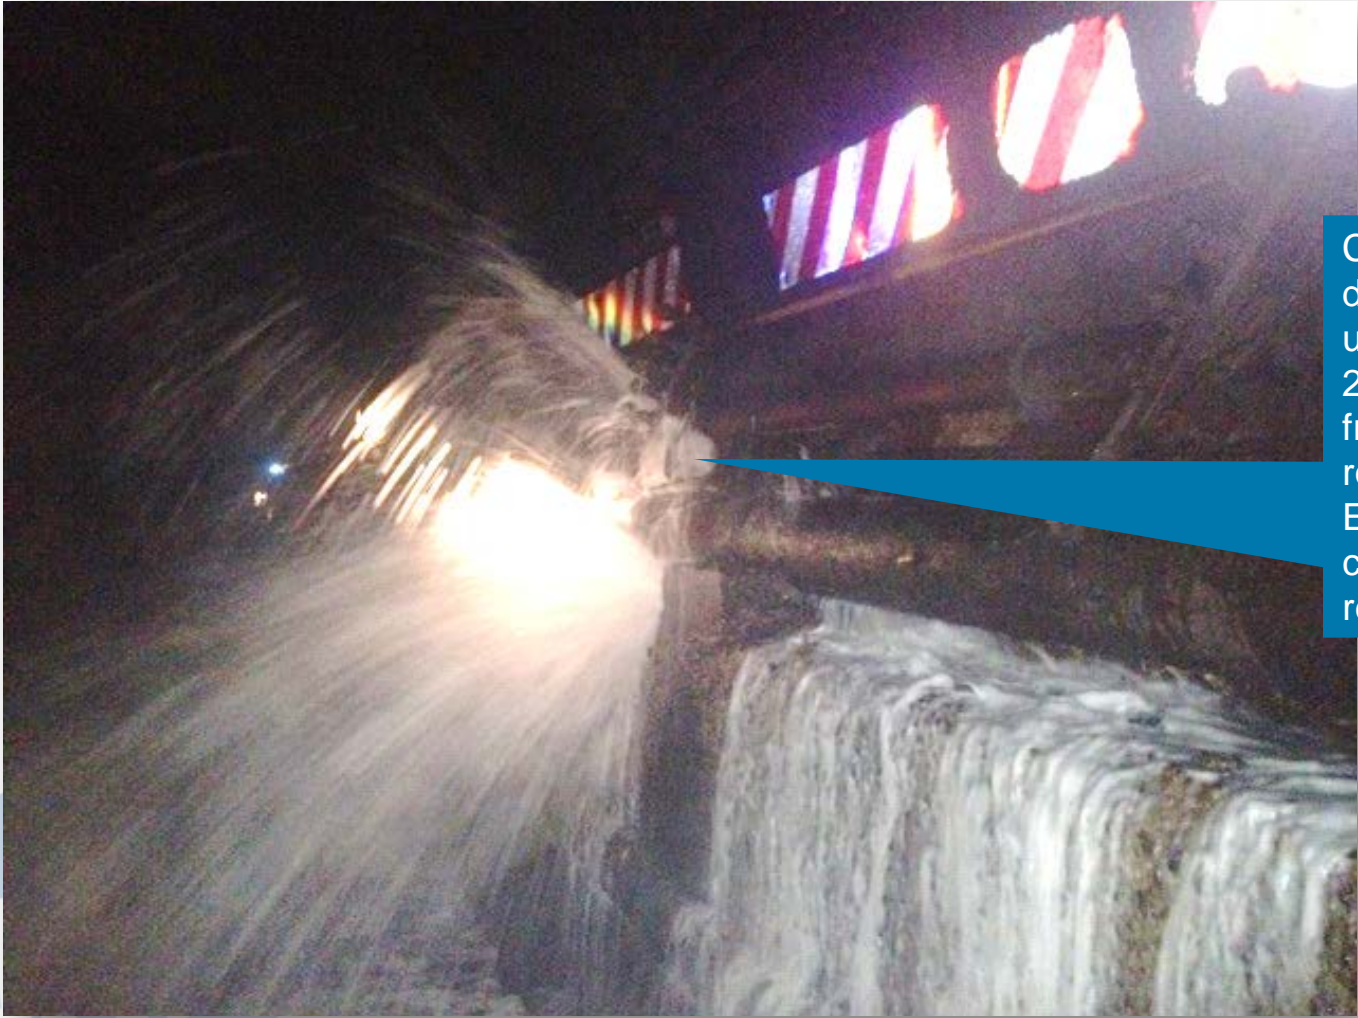
Canarsie L tube pump discharge line ruptured under normal loads April 24 with excessive stress from Sandy event likely root cause
Emergency repairs and customer delays resulted

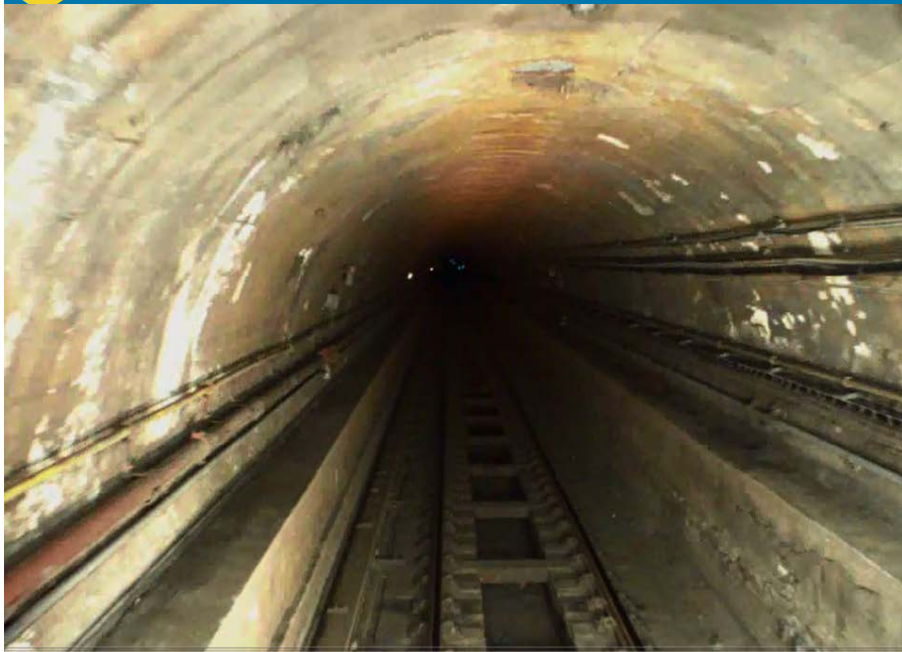
R Montague tube

- Opened 1920
- Flooded to ceiling
- Longest tube in system (5000')
- Re-entered service Dec 21
- Extensive damage to all systems

Montague and Greenpoint tunnels must close due to Sandy-related damages

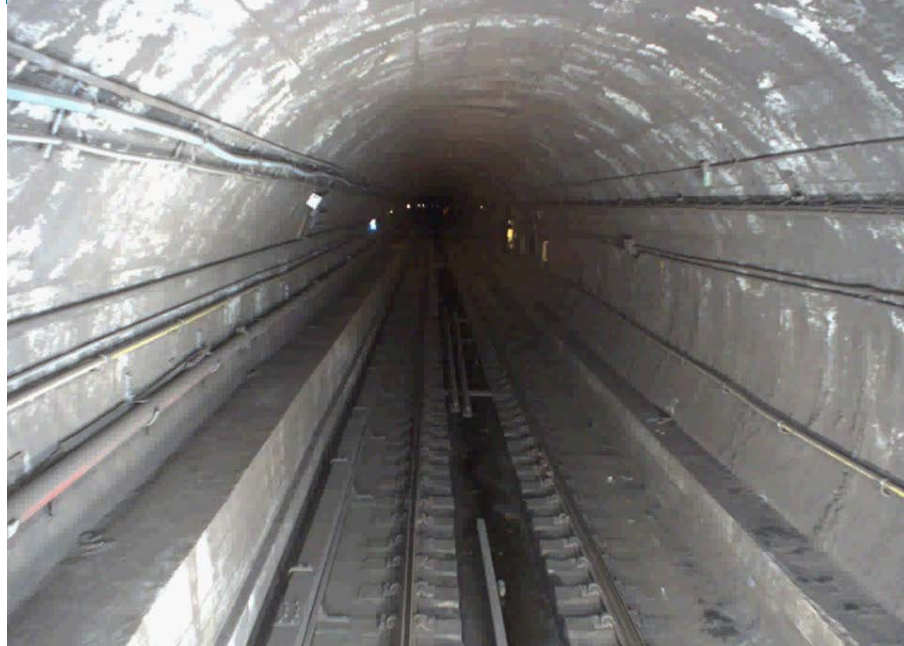
G Greenpoint tube

- Opened 1933
- Flooded to ceiling
- Re-entered service November 10
- Extensive damage to all systems
