Superstorm Sandy

Preparations, impact, recovery, and fortification

Society of American Military Engineers
September 17, 2013

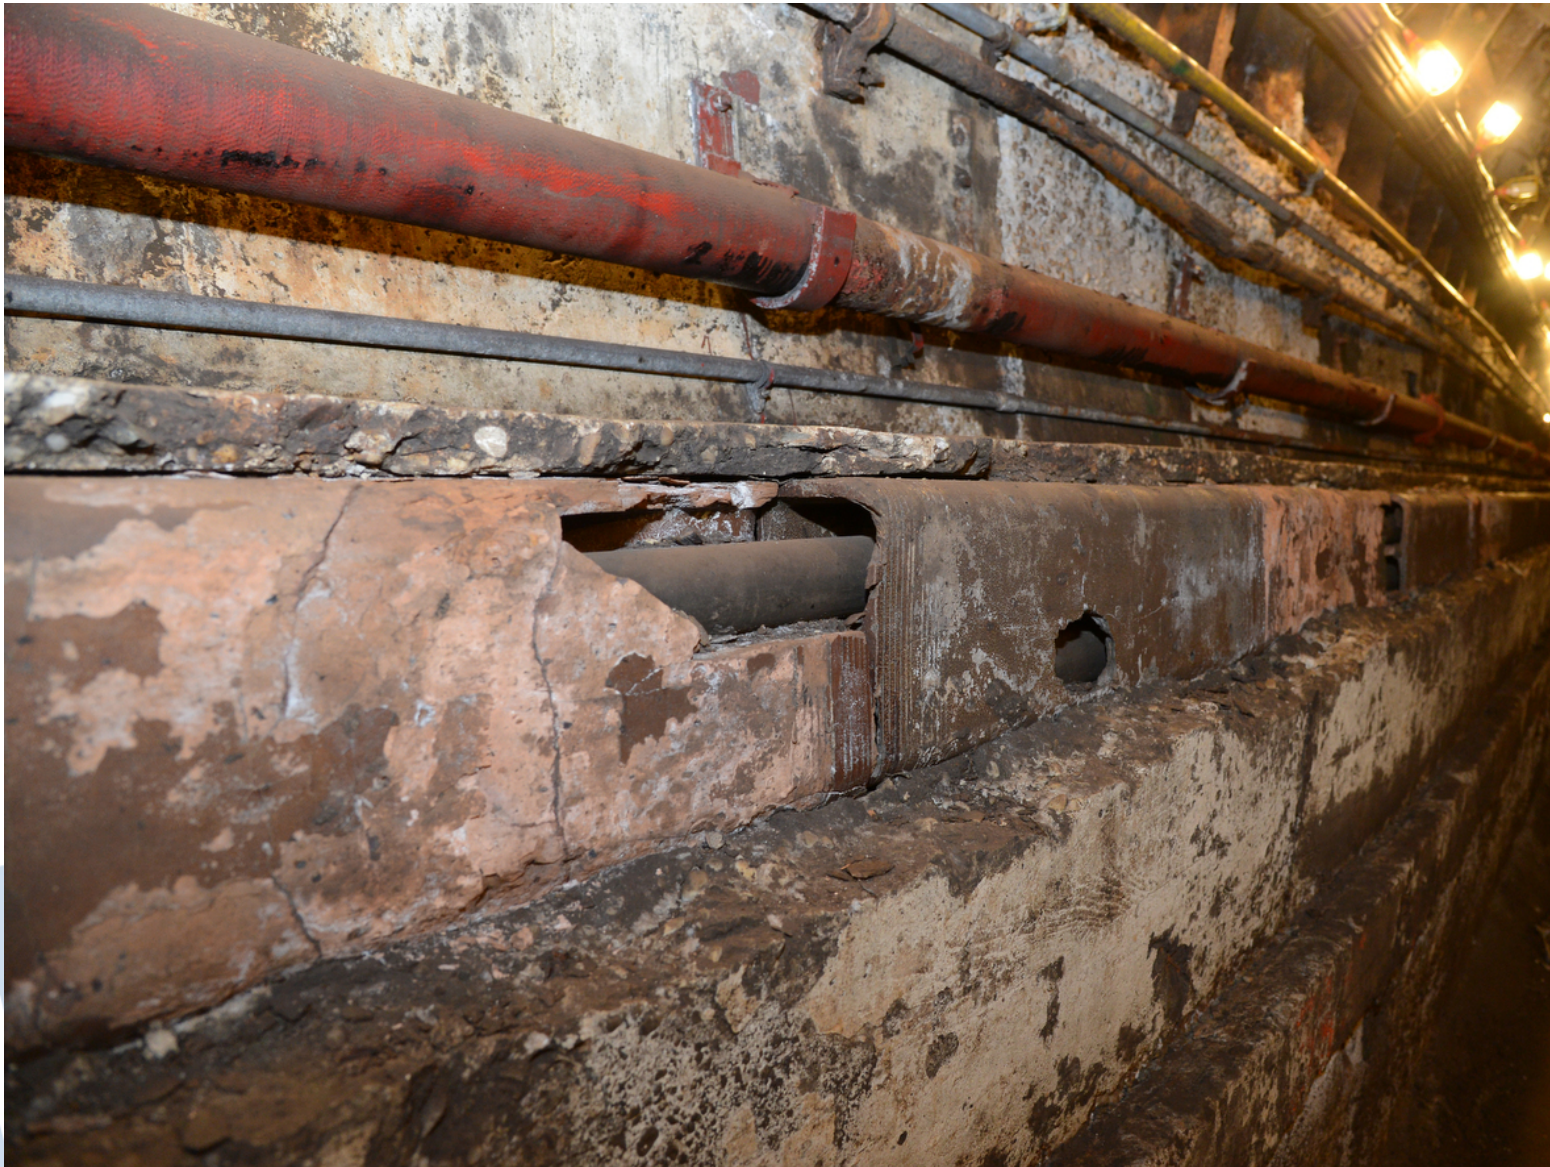
Damage makes pulling cable without rebuilding of the 28,000 linear feet of the duct bank infeasible

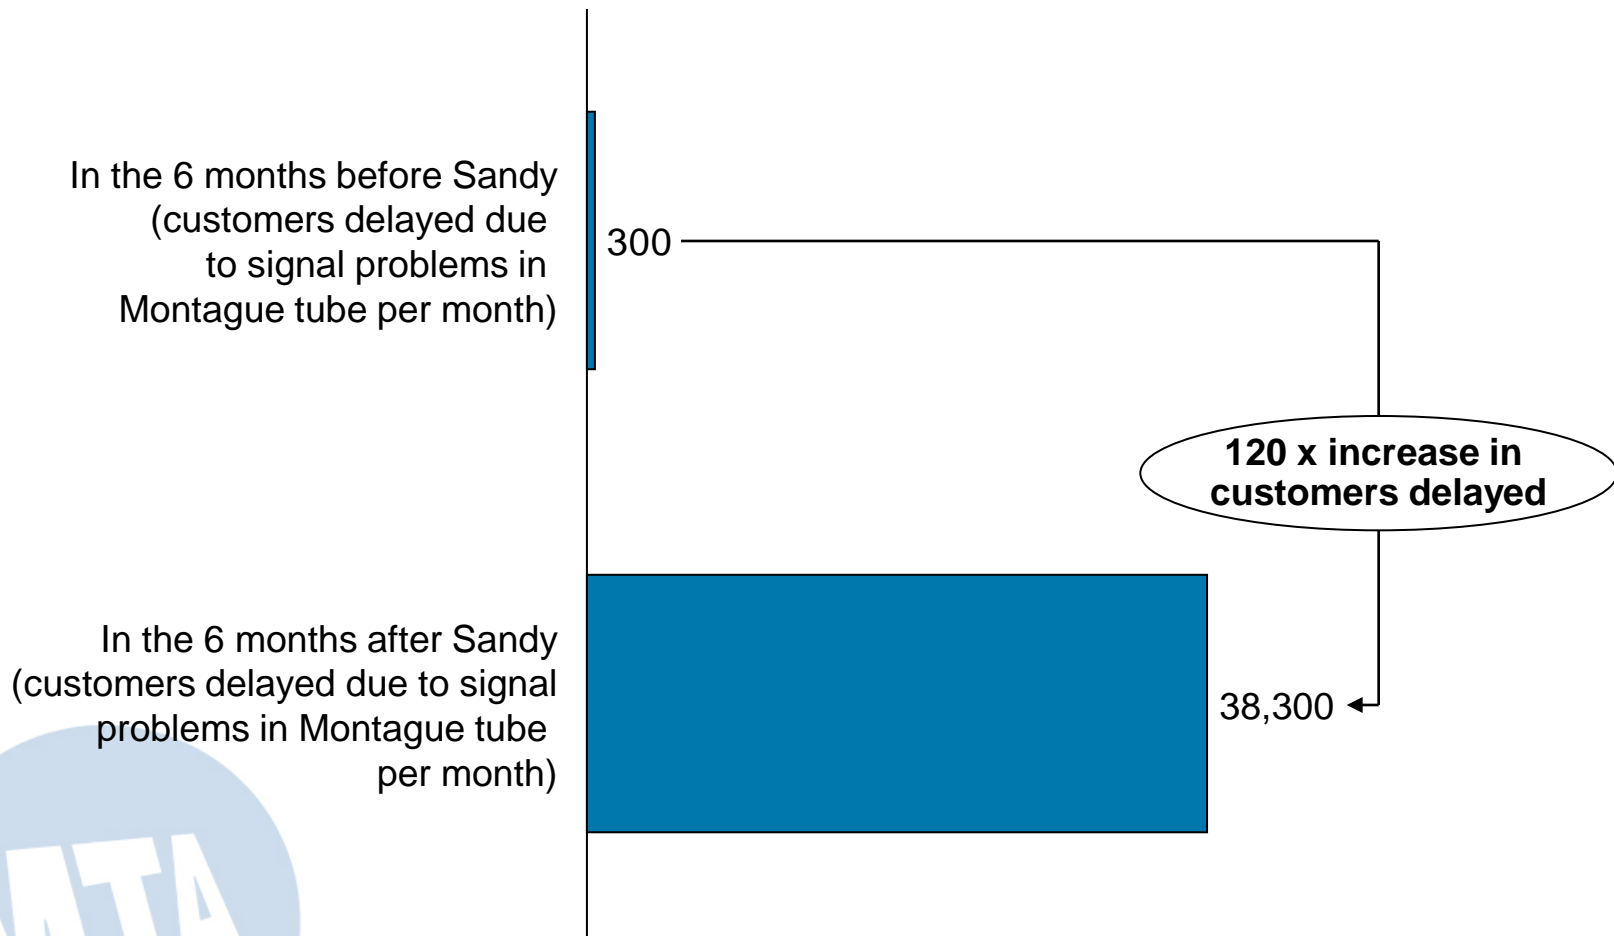
Failures affecting customers have dramatically increased in some areas post-Sandy

Number of customers delayed per month due to signal failures in Montague Tube

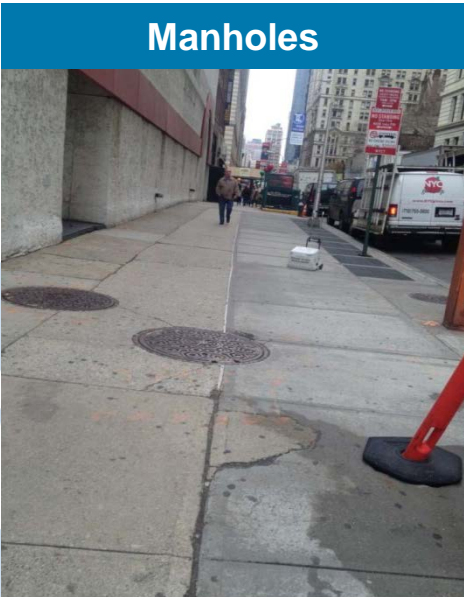
6 critical Lower Manhattan stations host 540 points of potential water penetration – solutions being developed for all

Multiple types of water ingress vulnerabilities exist

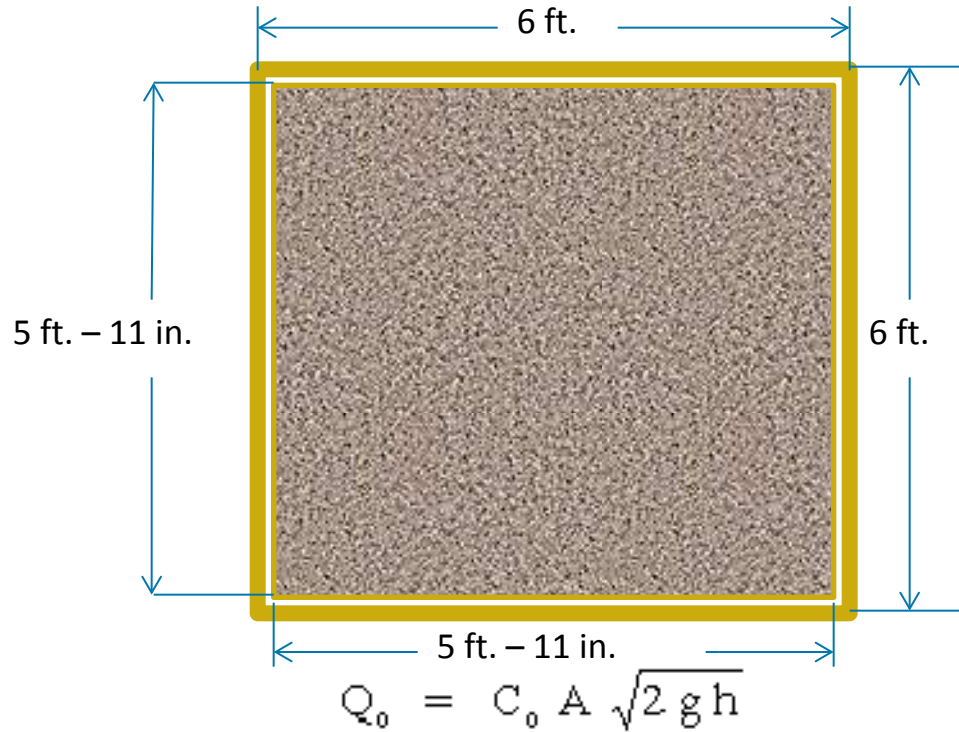
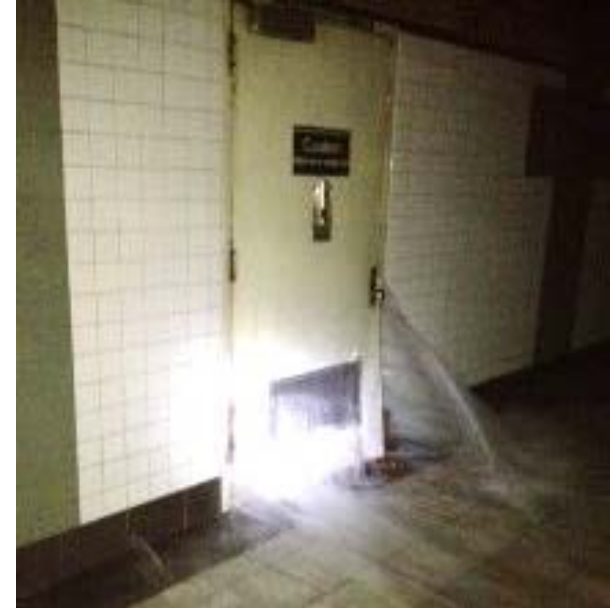
The engineering challenge is formidable – small openings can deliver huge amounts of water under pressure

Coefficient $C = 0.67$

$g = 32.2 \text{ ft./sec/sec}$

$h = 3.0 \text{ ft. water head}$

$Q = 9.25 \text{ cu. ft./sec} = 4,152 \text{ gal/min} = 249,120 \text{ gal/hr.}$

In 4 hrs.: approximately **1 M gallons** would have entered
